## **1. INTRODUCTION**

### **1.1 Overview of Mir Photo/TV Survey**

STS-63 was the Shuttle's first rendezvous with the Mir station. Over 1000 photographs and 10 hours of video were acquired during the rendezvous. The Image Science & Analysis Group (IS & AG) initiated several analysis tasks using the returned imagery data based on user requirements. They were to:

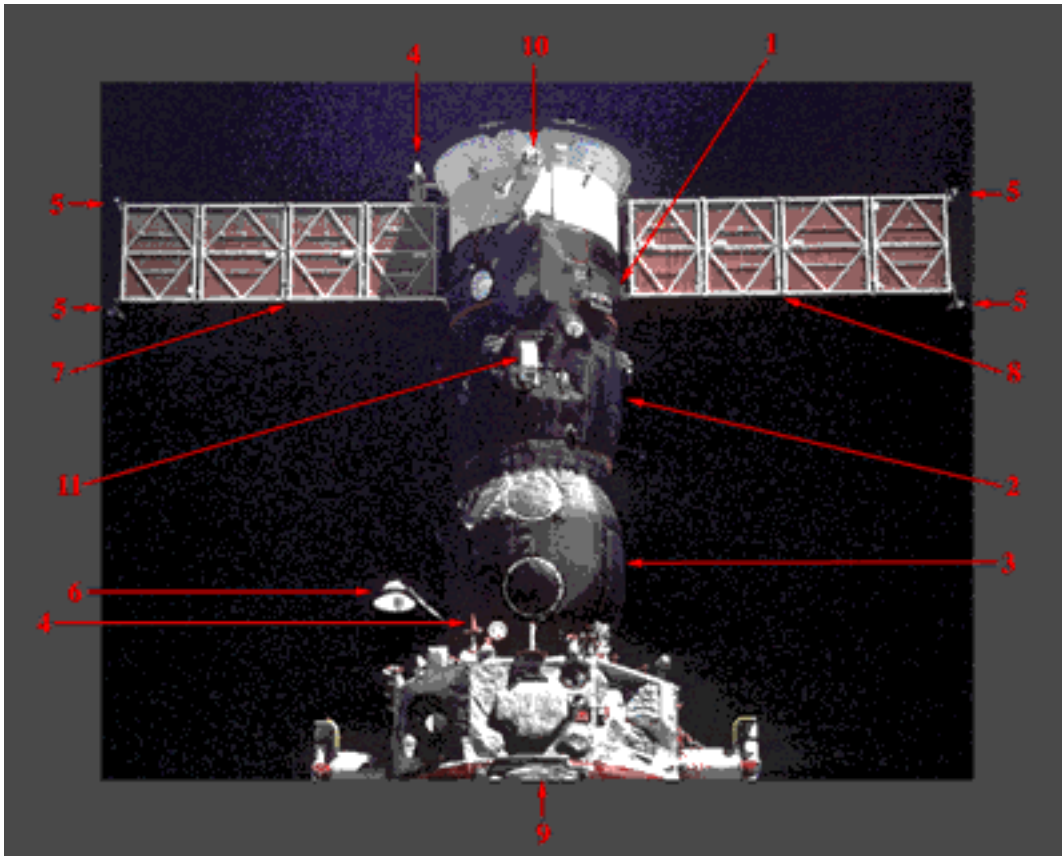
**Figure 2-B Progress M Capsule / Kvant 1 Module**

A “white box” located in the middle of the propellant section is not labeled in any diagrams.

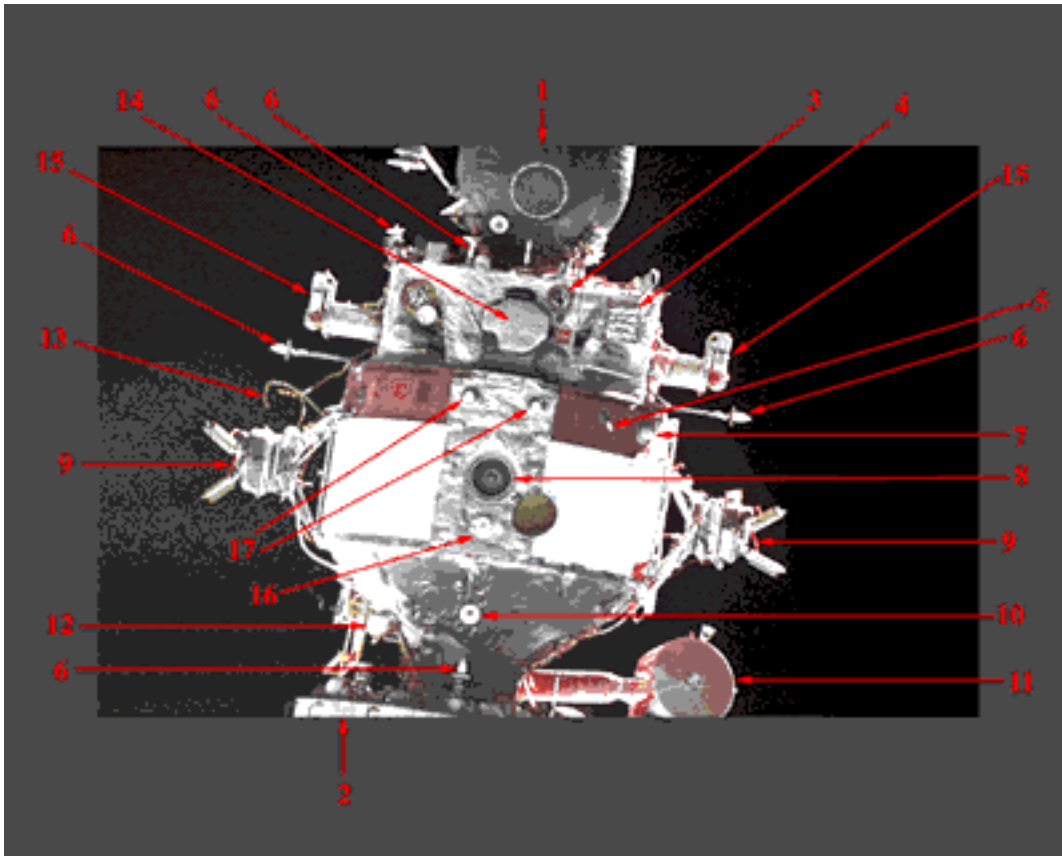
**Figure 2-C Kvant 1 Module / Progress M / Mir Base Block**

Two large "L" shape extensions on either side of Kvant 1 are not labeled in any diagrams.

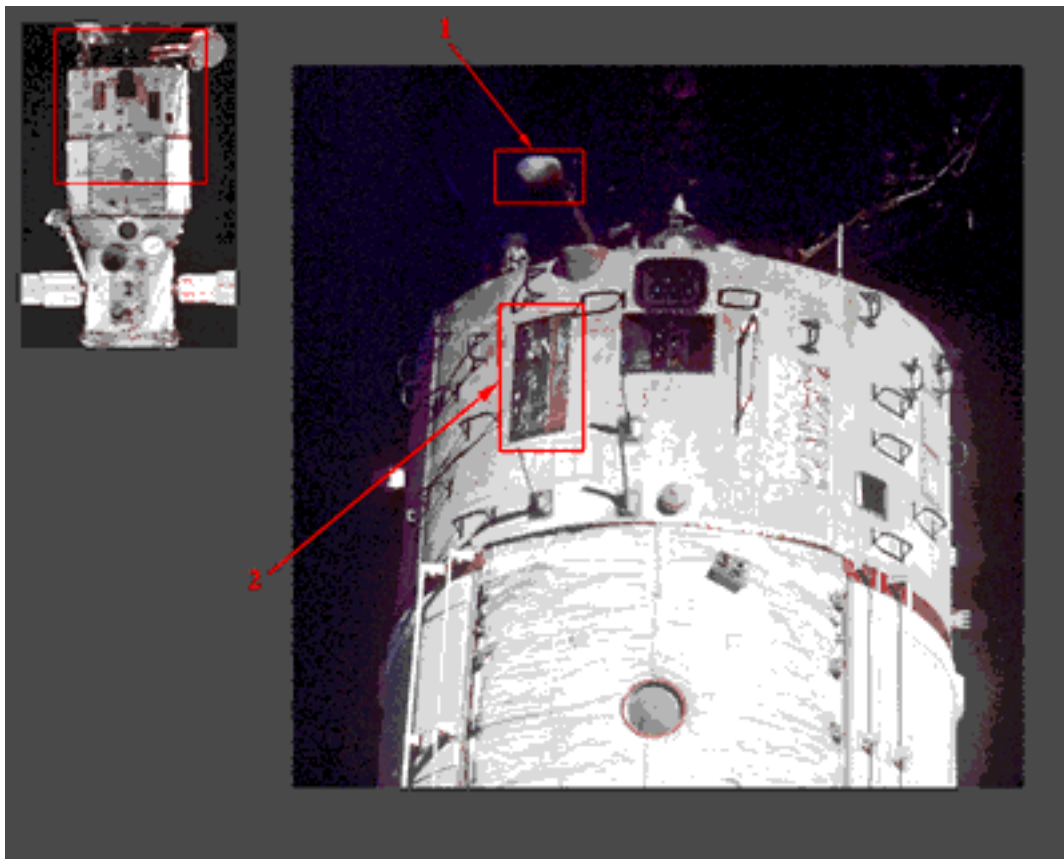
**Figure 3-A Mir Base Block**

Area [1] reveals the prominent dark brown discoloration seen on the Igla antenna. One possible reason for this discoloration could be deposition of particles (hydrogen, carbon dioxide, air and other micro contaminants) expelled from three drainage holes located just above the field-of-view on the forward section of the Kvant module.

Area [2] shows the damage on the meteoroid impact sensor surface material. Although two sensors are visible in this view, damage is only apparent on one. Three 95 cm by 15 cm strips appear to make up this panel. One of these strips appears to be missing. Additionally, a circular area with a 30 cm diameter appears to have surface material peeled off.

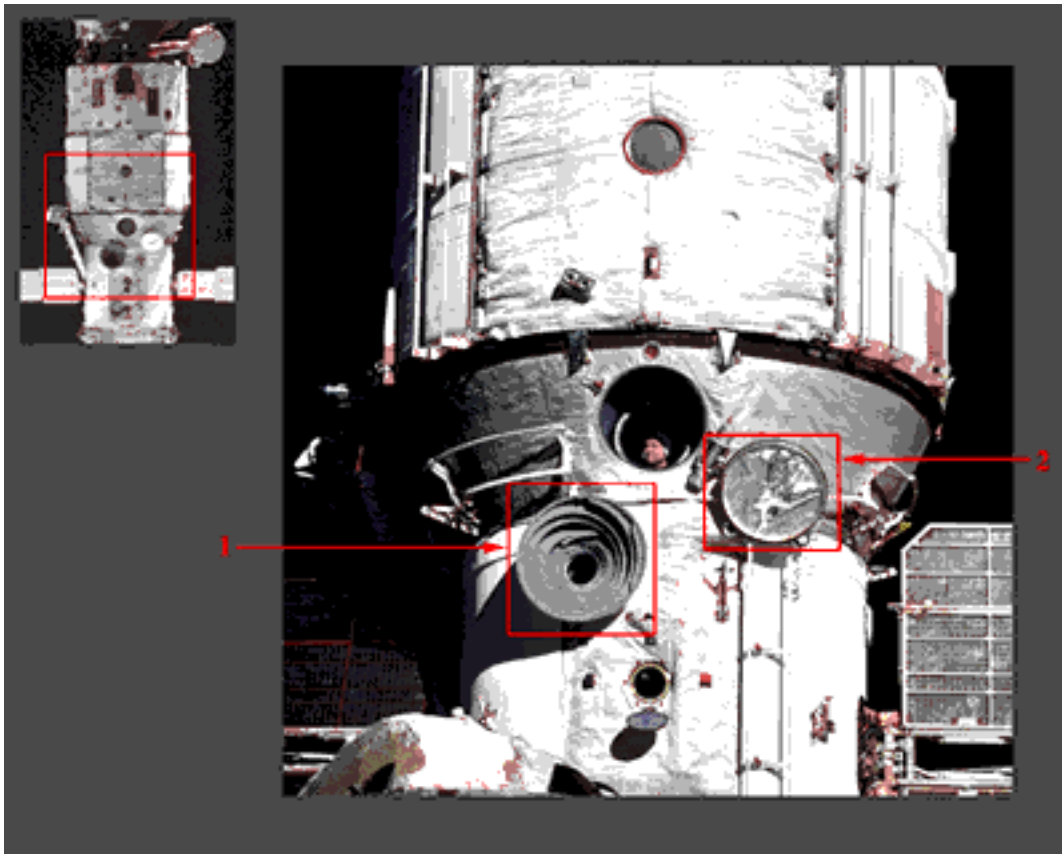
**Figure 3-B Mir Base Block Working Compartment**

Area [1] : Four possible impact damage locations are seen on the gray sunshade. The dimensions of these range between  $4 \text{ cm}^2$  and  $9 \text{ cm}^2$ . Analysis of the intensity variation on these damaged areas indicates a coarser surface than the surrounding region and suggests that the damage is caused by external impacts.

Video imagery of the Mir station during the rendezvous did reveal an alternate source for detecting plume impingement. A torn foil cover on one of the Mir Core ports (see Figure 3-B) appeared to oscillate at different times during the approach and backaway. Observances of this motion were correlated with Shuttle RCS thruster firing data during the approach and backaway. A strong correlation was found to exist between the foil cover oscillation and the firings of the F2F and F3F thrusters. No measurements could be gleaned from this analysis, however, since both the material type and the exact nature of the tear could not be identified.

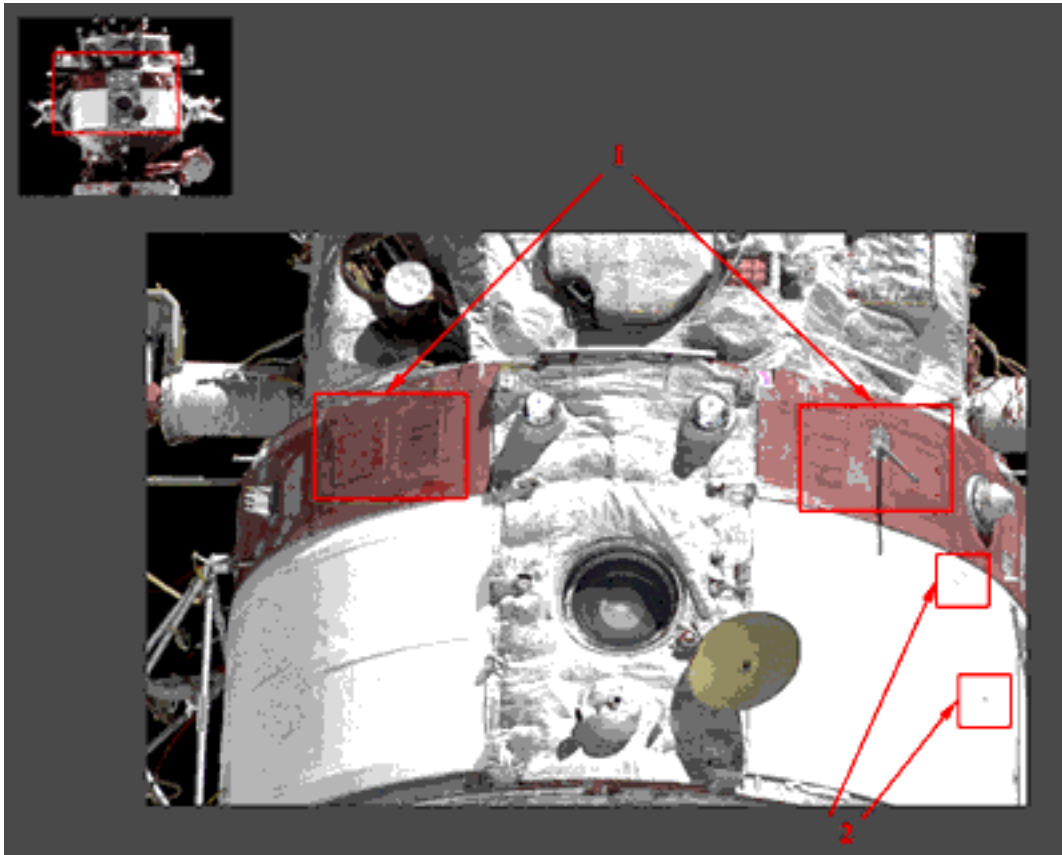
**Figure 3-C Kvant Module**

Area [1]: On the Kvant module, four attached patches of varying color shades are visible. The patches reveal color differences between the two areas that are not attributable to lighting differences.

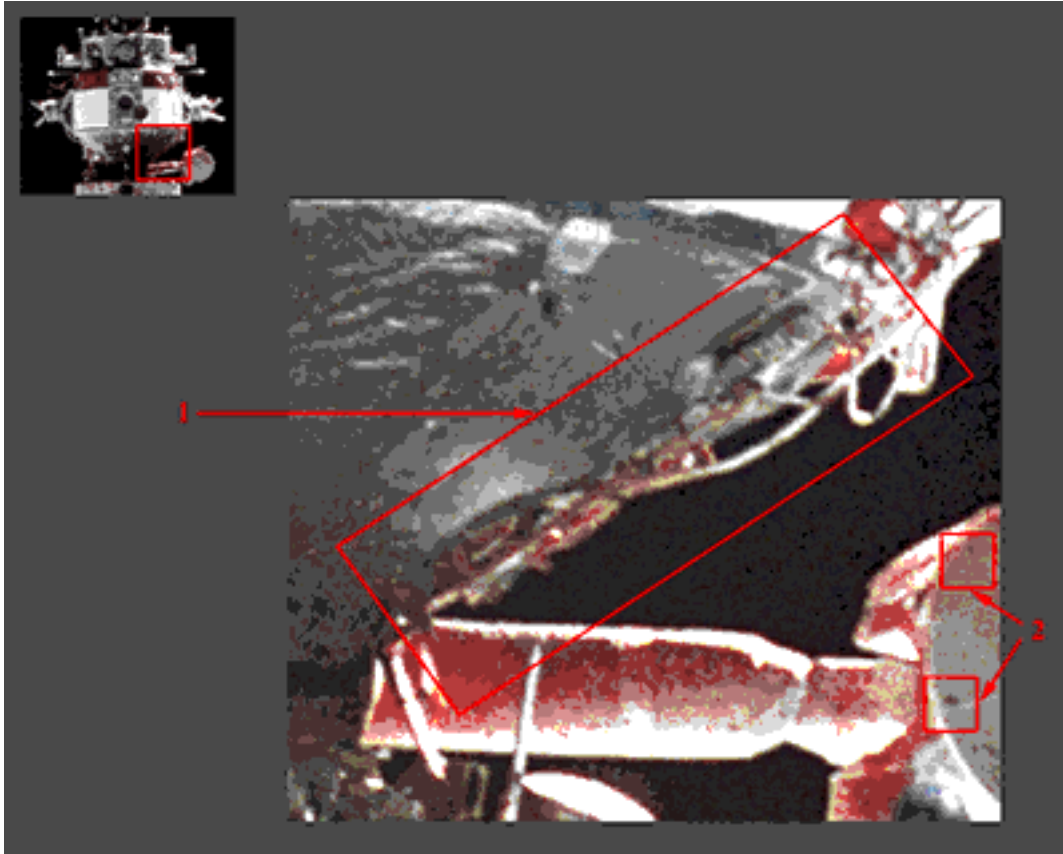
**Figure 3-D Kvant Module Forward Conical Section**

Area [1]: One end of the thermal protection blanket appears to be loose around the forward end of the Kvant module. [A more detailed view of this damage location can be seen on 35 mm film, roll 54, frame 22.] When the Kvant module was originally docked to the Mir station (in March of 1987), a foreign object was jammed in the docking unit and hampered the hard docking of the Kvant module to the Mir Base Block. An Extra Vehicular Activity (EVA) of more than 3.5 hours was required to dislodge the object. The physical nature of the EVA operation may have resulted in the thermal blanket damage on the Kvant module.

Area [2]: Dark spots were observed on the Luch antenna dish and supporting truss. The discoloration pattern may have resulted from sprayed contaminants. One possible source could be the eject holes in the forward section of the Kvant module designed to purge hydrogen, carbon dioxide, and air. The dimensions of the dark spots seen on the Luch antenna range between 9 cm<sup>2</sup> and 16 cm<sup>2</sup>.

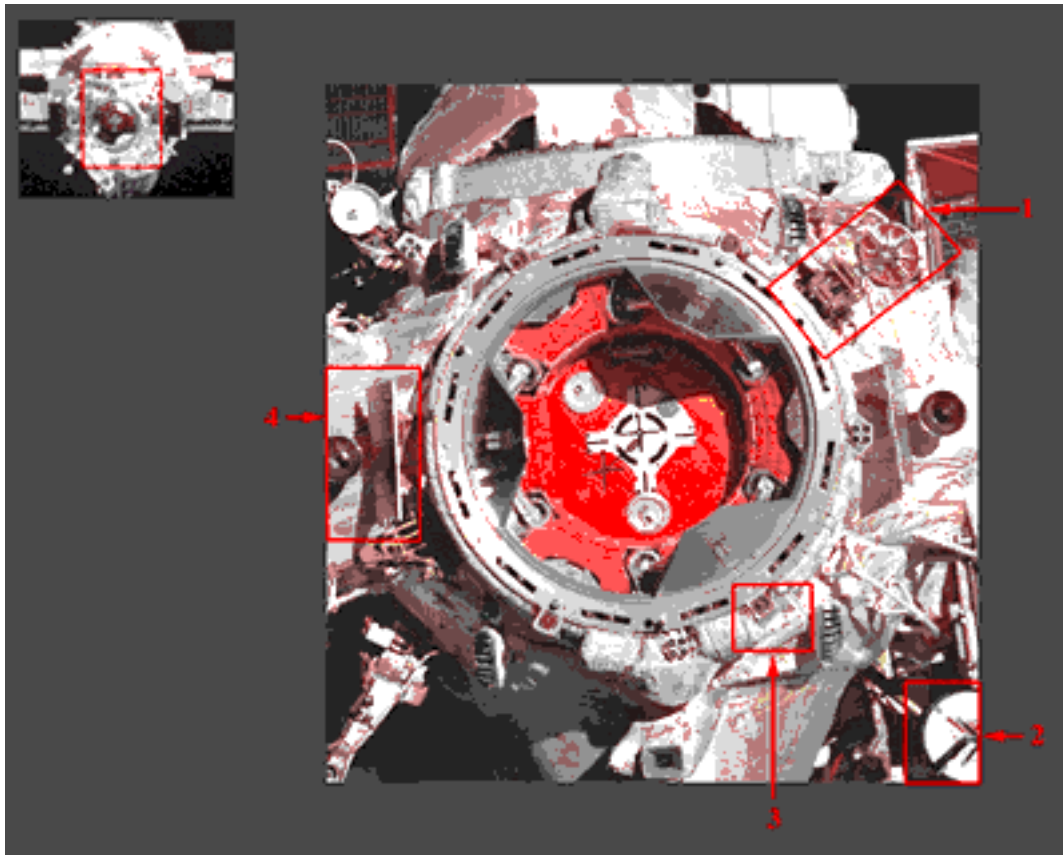
**Figure 3-E Kristall Module APDU - Centerline**

Area [1]: The Igla antenna system on the docking module is pointed toward the Kristall solar arrays. The antenna is probably not in an active mode in this orientation.

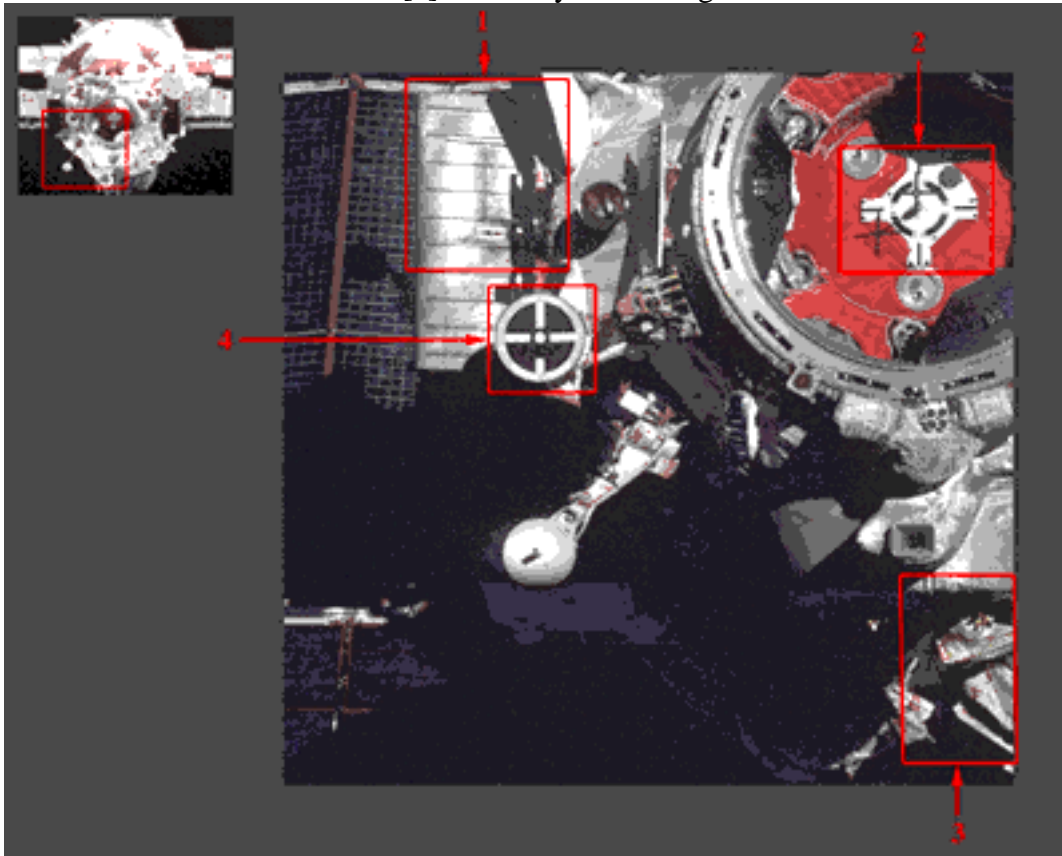
**Figure 3-F Kristall Module APDU - Off-center**

Area [1]: The mooring and stabilization engines may have caused the discoloration on the engine jackets as well as the back plate beneath the engines. The discoloration on the outer edges of the back plate also suggests that engine thrust contaminants go beyond the edges. This implies the possibility that damage could occur to the Kristall solar array panels from these thruster firings.

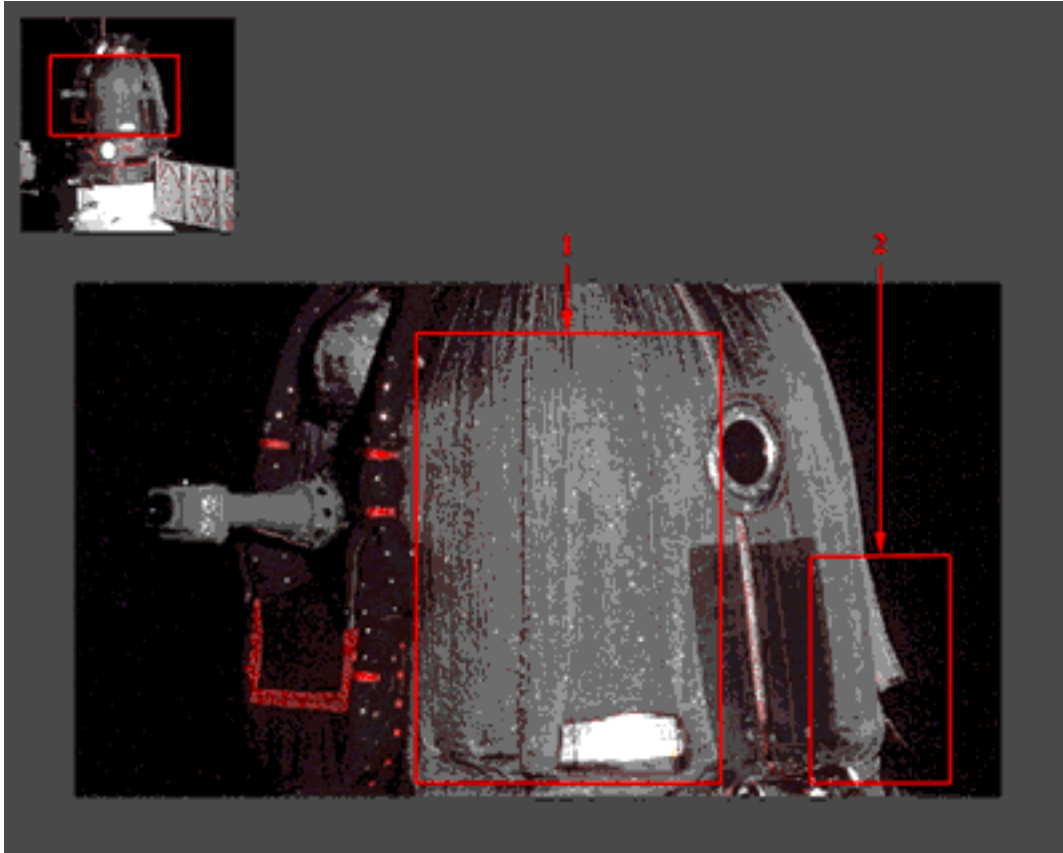
**Figure 3-G Soyuz-TM Descent Module**

Area [1]: Several small light discolored areas are seen on the thermal blanket of the Soyuz-TM descent module. This type of damage on the thermal blanket could be due to external impacts.

Area [2]: A loose thermal blanket is visible on the Soyuz-TM capsule. While this tear does not appear to be significant (~12 cm offset from the surface), severely damaged insulation could cause condensation during temperature extremes that occur during orbit. Soyuz-TM 9 (launched in February, 1990) experienced a more severe loss of thermal protection. Cosmonauts en-route to the Mir complex noticed that three of the eight thermal blankets came loose. These blankets were finally repaired through an extensive EVA after docking. Prior to the repair, the orientation of the entire Mir complex had to constantly be altered to maintain the proper temperature gradient for the Soyuz-TM capsule.

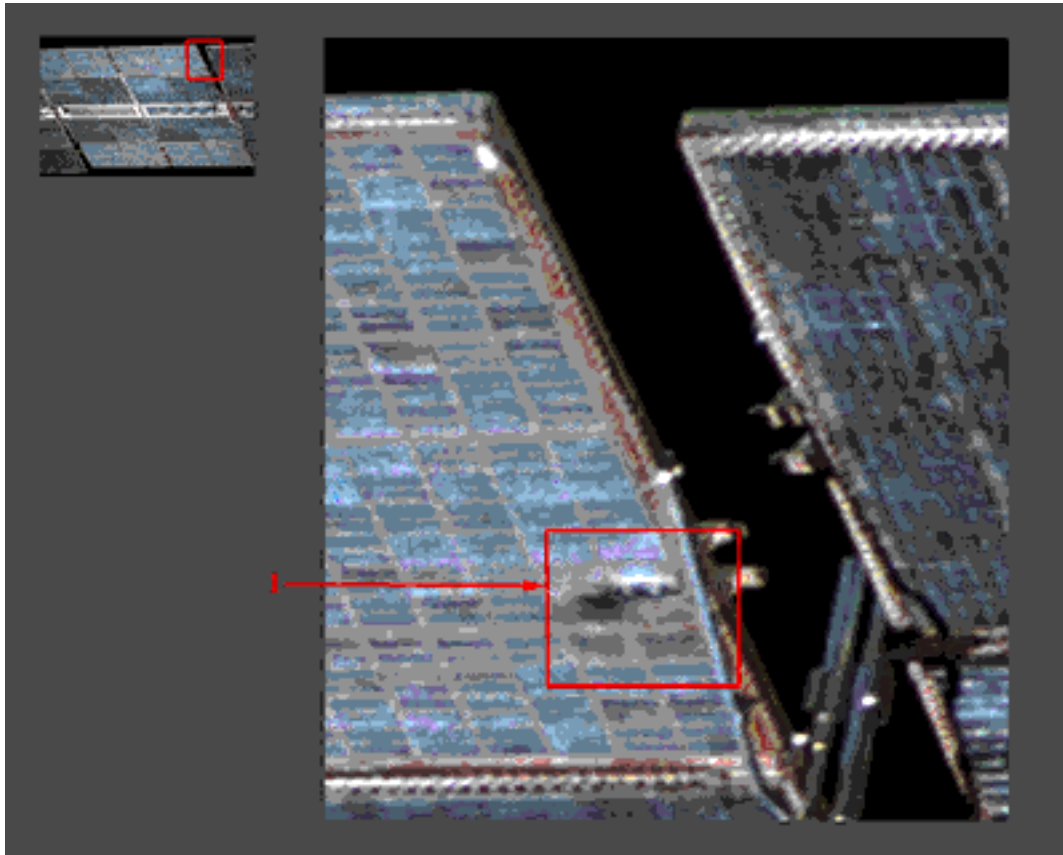
**Figure 3-H Solar Array off Mir Base Block**

Area [1]: The damage in Area [1] illustrates the possibility of an orbital debris strike where an object has apparently traveled completely through a panel. This area of damage encompassed a  $27 \text{ cm}^2$  area. At least six adjacent cells appear to have suffered ancillary damage. Further analysis of this particular panel indicates slight warping within the frame structure.

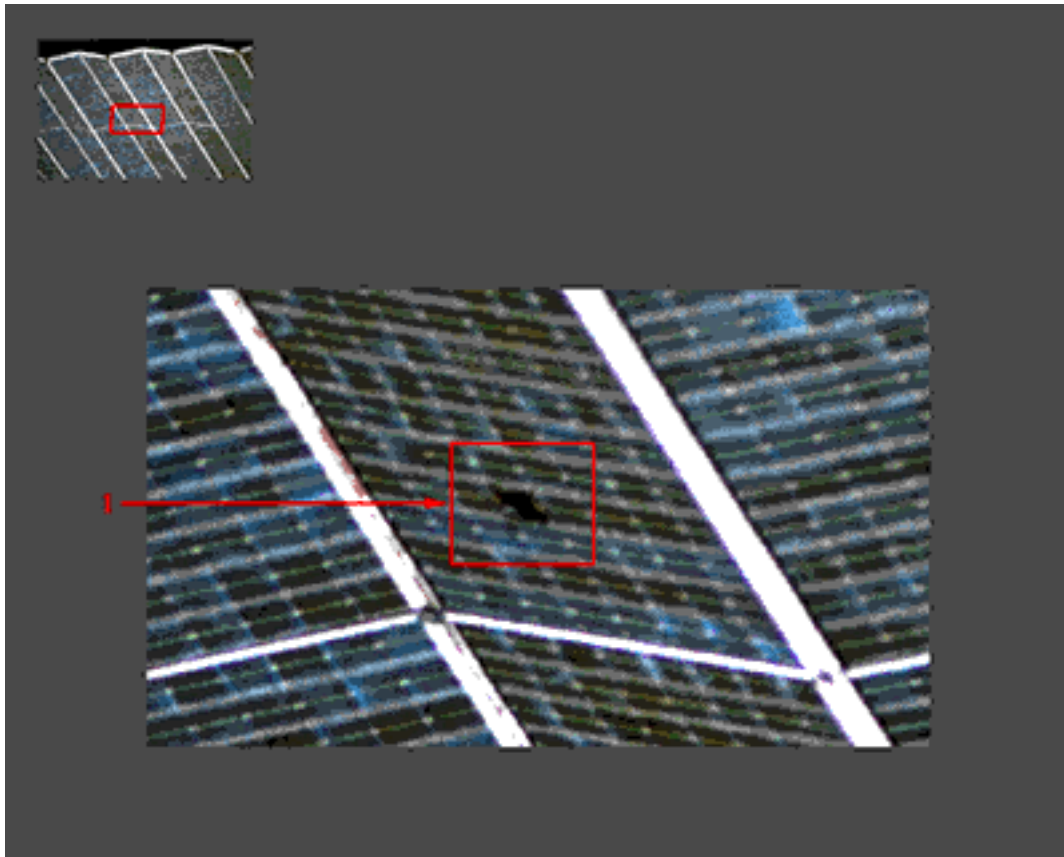
**Figure 3-I Port Solar Array off Kristall Module**

Area [1]: This top side view of the Kristall solar array reveals damage to one of the panels. Two or three individual solar cells are damaged or missing at this location. This could have been due to an external impact or electrical damage. The damage is approximately between  $4 \text{ cm}^2$  and  $16 \text{ cm}^2$  per side. The gray scale intensity variations of the damaged area do not correlate with that of the background. This implies that the hole does not go cleanly through the panel.

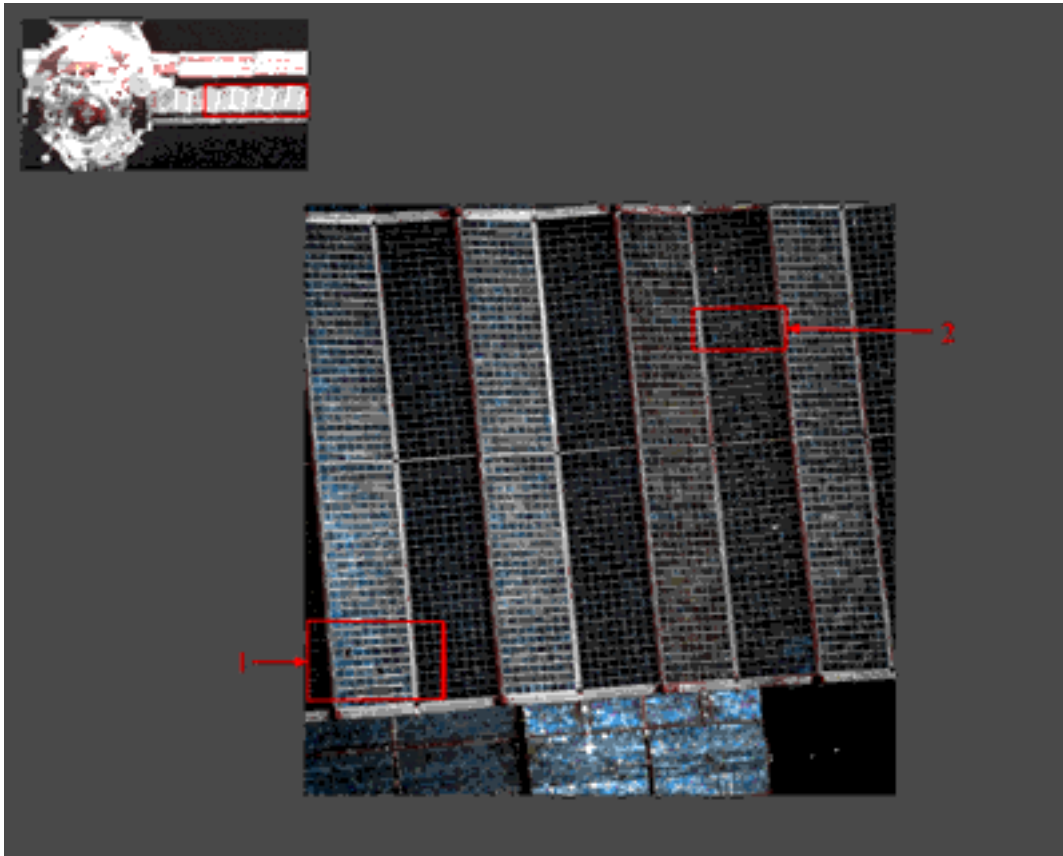
**Figure 3-J Starboard Solar Array off Kristall Module**

Area [1]: This top side view of the Kristall solar array reveals damage to two cells at the bottom left corner of the image. Two individual solar cells are damaged at this location. The damage was measured to be  $25 \text{ cm}^2$ .

Area [2]: This view reveals further damage to another solar cell located at the top right corner of the image. The damage size was measured to be about  $25 \text{ cm}^2$ .

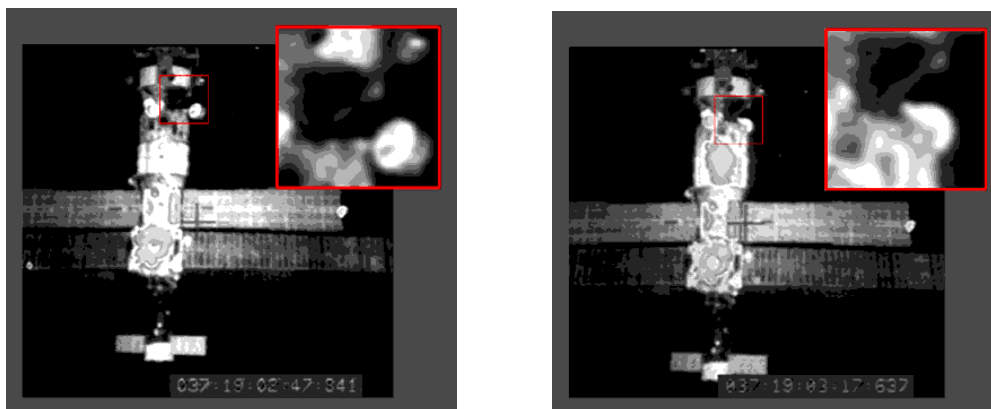
**Figure 7-A Luch Antenna Arm Orientation**

The CTVC centerline camera could not image the Luch antenna arm while it was in motion during the approach. The MLA camera at the PLB 'D' position tracks the arm motion during this time. (See Figure 7-A.) The Luch antenna arm starts to rotate at approximately 37:19:02:48 GMT and stops at approximately 37:19:05:02 GMT. The antenna is initially oriented at  $36^\circ$  about the Mir X-axis and  $22^\circ$  about the Z-axis (pointing above and toward the starboard side of the Orbiter.) The angular motion of the antenna arm is about the Mir's X-axis with the dish turning away from the Space Shuttle. The rotation rate of the antenna arm was measured to be  $35^\circ/\text{minute}$ .

The Luch antenna arm is also in motion during the fly-around as seen on PLB camera 'D'. The time interval for this motion is 37:20:40:37 GMT to 37:20:41:26 GMT. Since the Mir and Orbiter are both changing attitudes, no accurate measure of antenna orientation could be calculated.

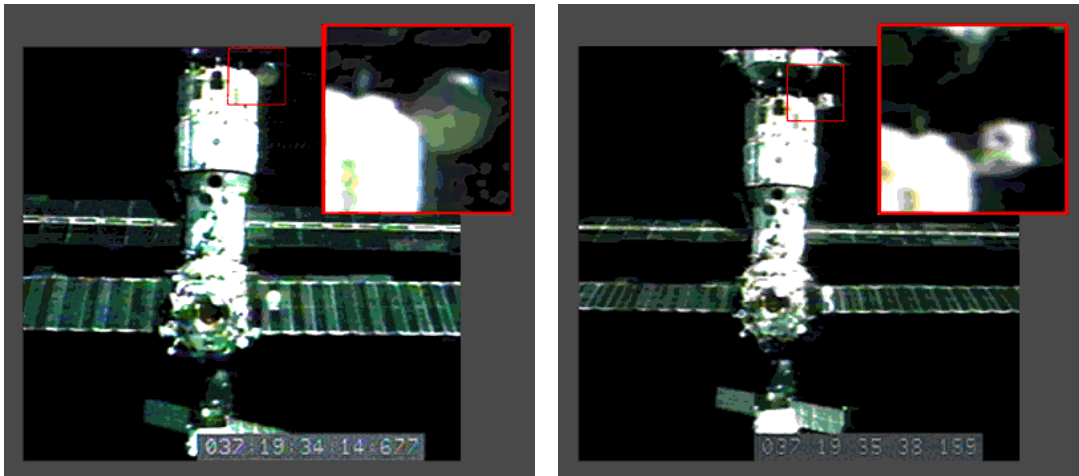
**Figure 7-B Luch Antenna Dish Orientation**

The Luch antenna dish first enters the CTVC centerline camera's field-of-view at 037:19:34:01 GMT. This time is during the early part of backaway when the Orbiter is about 80 feet away from the Mir Station. (See Figure 7-B.) Initially, the dish is oriented at  $9^{\circ}$  about the Mir X-axis and  $18^{\circ}$  about the Z-axis (pointed in the general direction toward, but below and off to the port side of the Orbiter.) The dish starts to rotate at 37:19:34:10 GMT and stops at 37:19:35:23 GMT. The antenna dish rotates  $10^{\circ}$  about the Mir X-axis and  $60^{\circ}$  about the Z-axis (with the antenna's orientation approximately parallel to the Mir's Y-Z plane.) The rotation rate of the antenna dish was measured at  $53^{\circ}$  /minute.

A second movement of the antenna dish was noted between 037:19:42:02 GMT and 037:19:43:32 GMT. The antenna dish rotated back, again pointing in the general direction of the centerline camera.
